Introduction

The main objective of this study is to recognize previously unknown early Cambrian limestone with archaeocyaths in the architectural elements of Spanish cultural heritage and identify the Cambrian geological unit and the geographical location from which come.

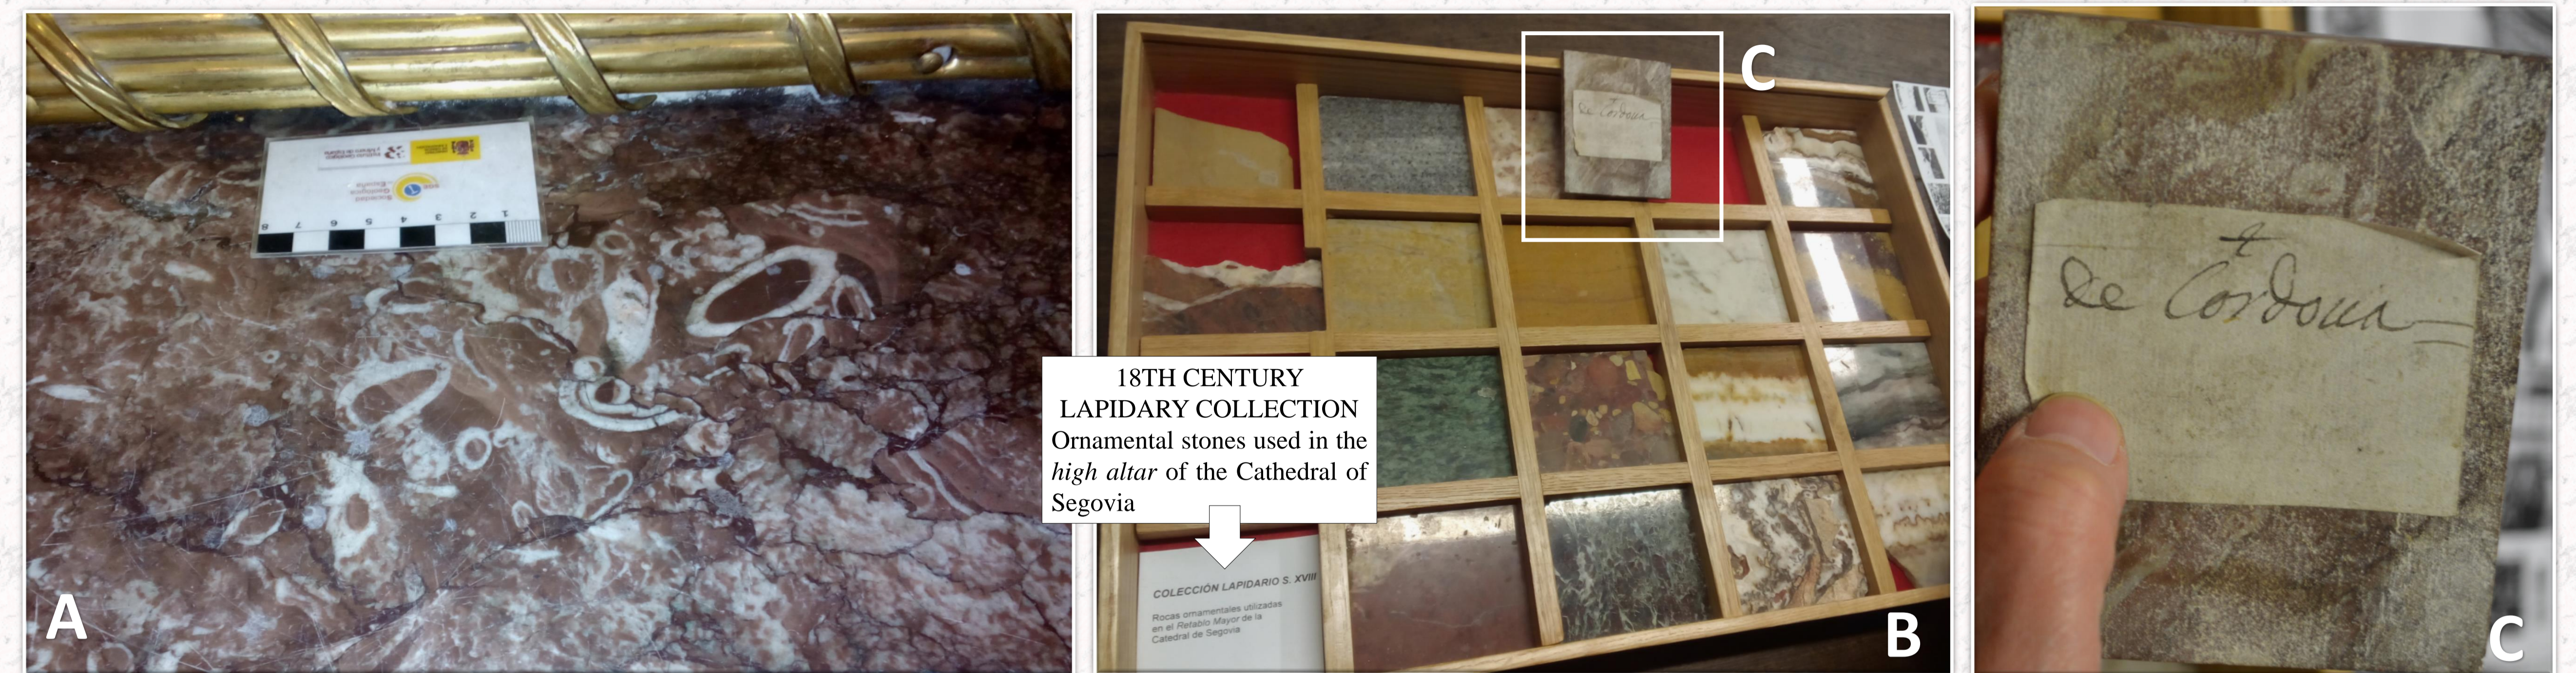
Figure 1. A) Detail of early Cambrian limestone with archaeocyaths in the high altar of the Cathedral of Segovia. B) Lapidary archive. C) According to lapidary the limestone with archaeocyaths used in the high altar comes from Córdoba [“de Cordova”].

Among the stone materials used in the monuments and buildings of the Spanish architectural historical heritage are some of early Cambrian limestone with archaeocyaths (Fig.1A). They can be both seen in the archaeological heritage of Roman times and in Christian cathedrals. In many cases, the location of the historic quarries from which the material was extracted is difficult because the mining labors have stopped long ago, or because a lack of record keeping.
